# ELEVATION CERTIFICATE

| SECTION A – PROPERTY INFORMATION | | FOR INSURANCE COMPANY USE |
|---|---|---|
| A2. Building Street Address (including Apt., Unit, Suite, and/or Bldg. No.) or P.O. Route and Box No.<br>258 LEADOFF DRIVE | | Company NAIC Number: |

A3. Property Description (Lot and Block Numbers, Tax Parcel Number, Legal Description, etc.)
LOT 136 DIAMOND SUBDIVISION, PHASE 2, PIN# 456-07-03-0015

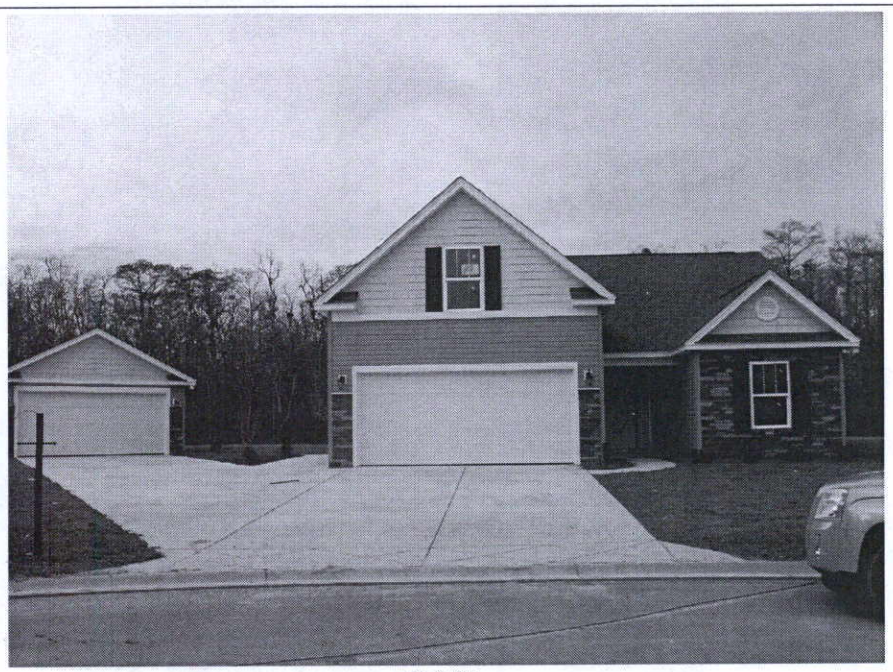
Photo One Caption FRONT VIEW 01/10/2017

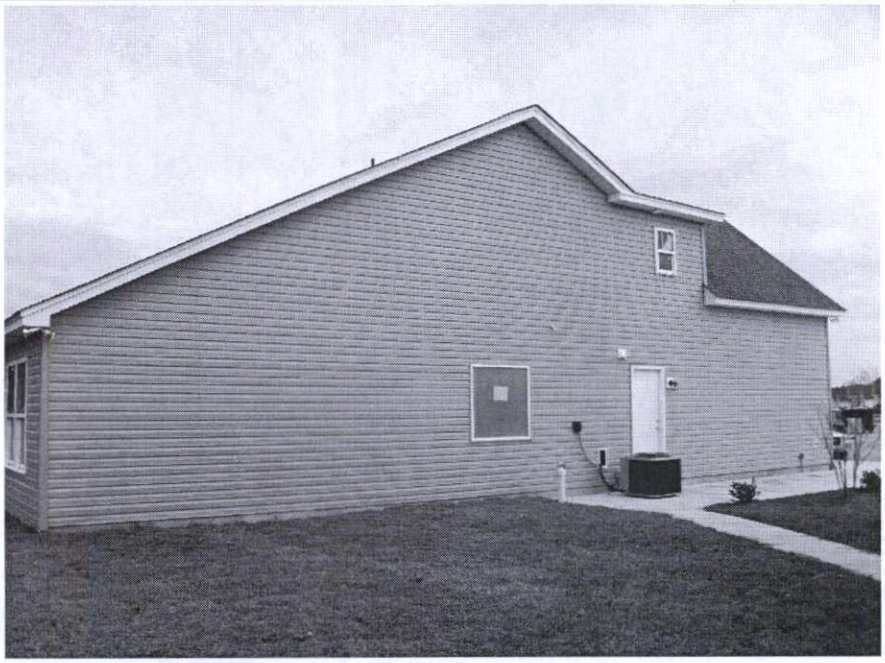
Photo One Caption LEFT SIDE VIEW 01/10/2017
