ELEVATION CERTIFICATE

SECTION A – PROPERTY INFORMATION		FOR INSURANCE COMPANY USE
A1. Building Owner's Name Perry & Shelley Richardson		Policy Number:
A2. Building Street Address (including Apt., Unit, Suite, and/or Bldg. No.) or P.O. Route and Box No. 683 Bucks Trail		Company NAIC Number:
City Longs	State South Carolina	ZIP Code 29568

A3. Property Description (Lot and Block Numbers, Tax Parcel Number, Legal Description, etc.)
Lot 58, Aberdeen Country Club (formerly Buck Creek Golf Plantation) Tax# 102-17-01-058 PIN# 266-12-01-0002

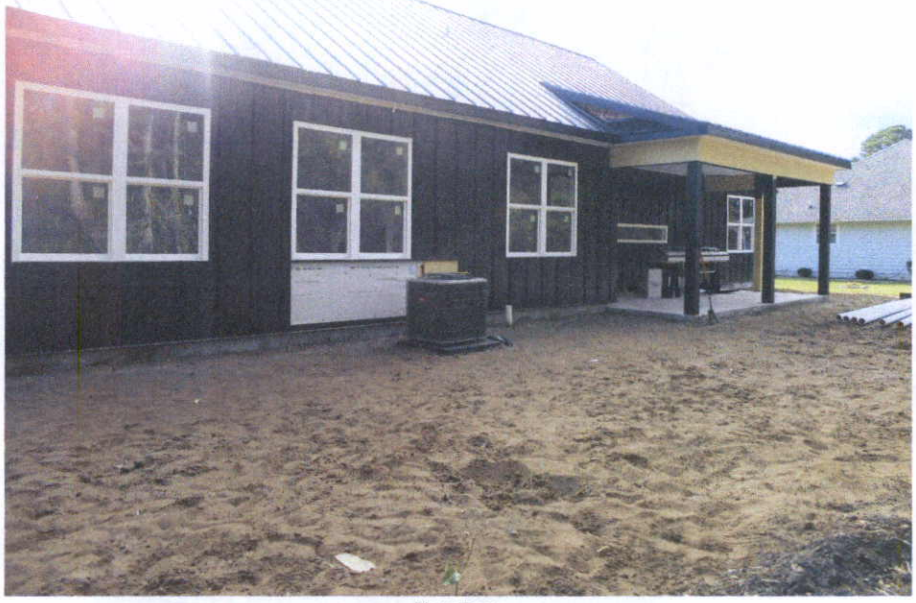
Photo Three Caption Rear 06/11/2018
